**Press the start button**

TECH Software

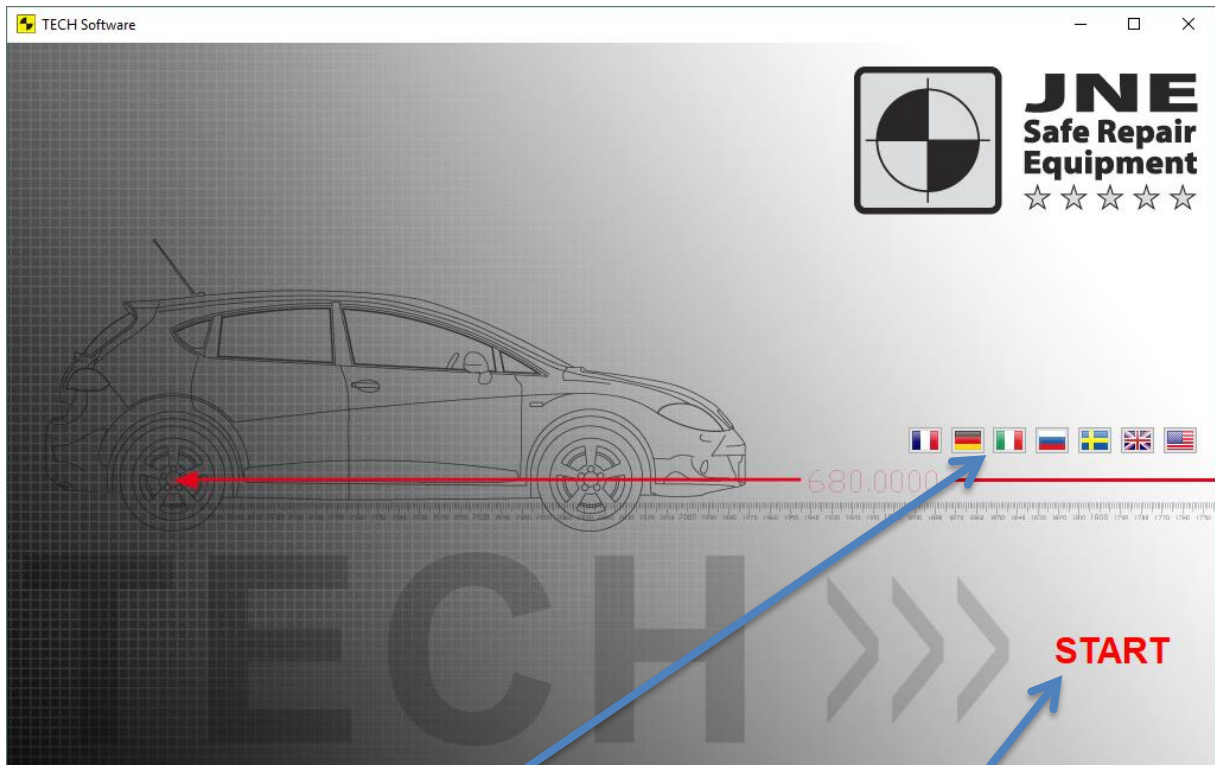
**Chose language**

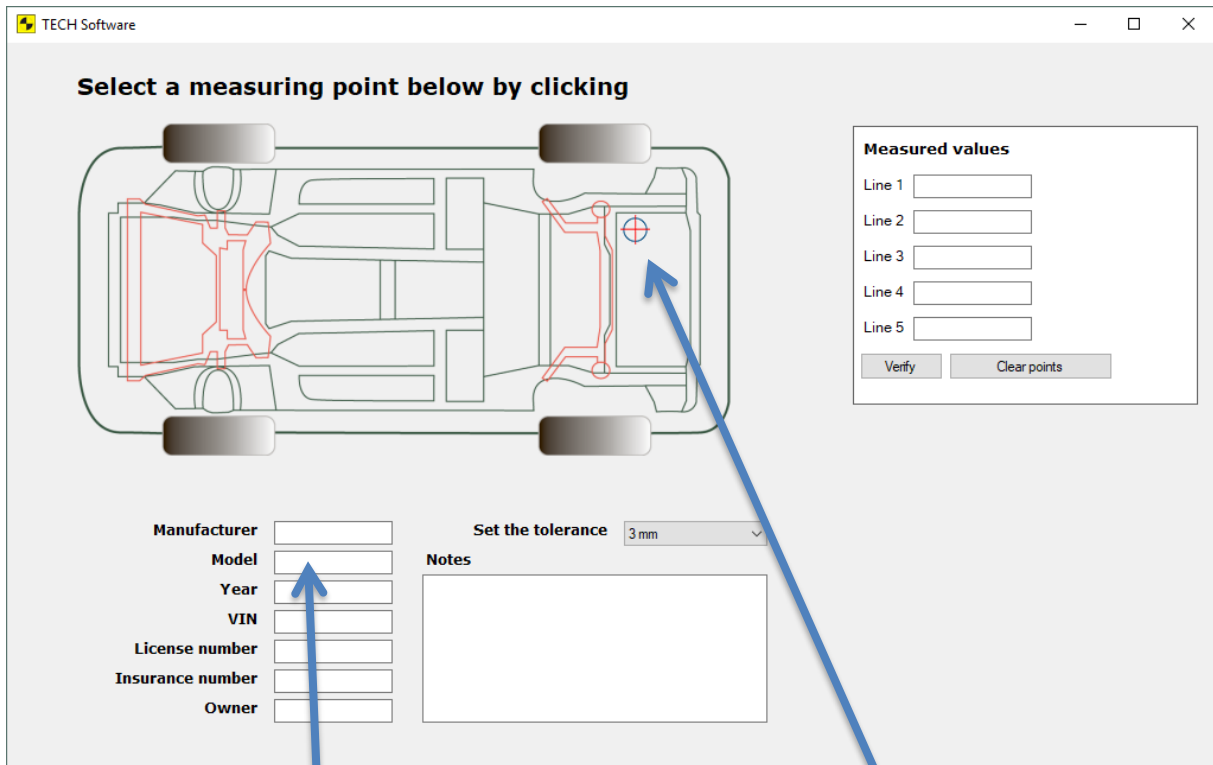
**Fill out the car details**

**Select by clicking where you want to start measuring from**

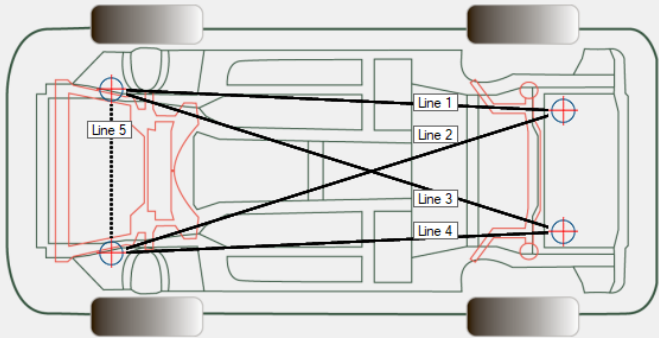
Please fill in the specification values and verify

Measured values	Spec. values
Line 1 1400	<input type="text"/>
Line 2 1900	<input type="text"/>
Line 3 1890	<input type="text"/>
Line 4 1406	<input type="text"/>
Line 5 900	<input type="text"/>

If the fields are red after verification, there are 3 possibilities:

1. The car is damaged
2. The points are not symmetric
3. The tolerance is wrong

Fill in the car manufacture's values for these lines, or values from another supplier of data.

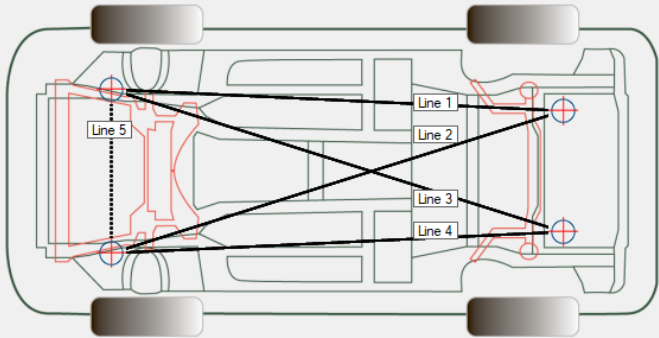
Example of a damage car

Measured values	Spec. values
Line 1	1400	1400
Line 2	1900	1900
Line 3	1890	1900
Line 4	1406	1406
Line 5	900	900

Measured values	Spec. values	
Line 1	1400	1400	✓
Line 2	1900	1900	✓
Line 3	1890	1900	! (red)
Line 4	1406	1406	✓
Line 5	900	900	✓

Example of a report on a damaged car

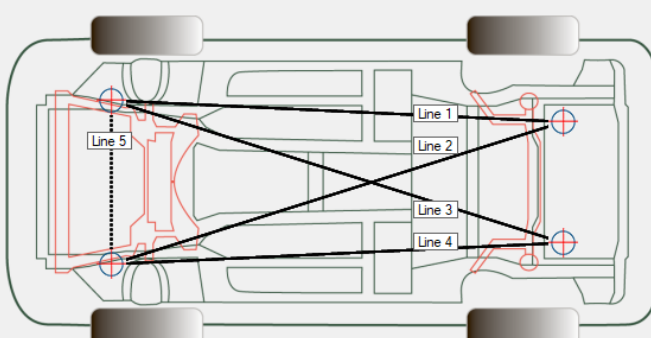
**Example of a non-symmetric car**

Measured values	Spec. values
Line 1	1400
Line 2	1900
Line 3	1890
Line 4	1406
Line 5	900

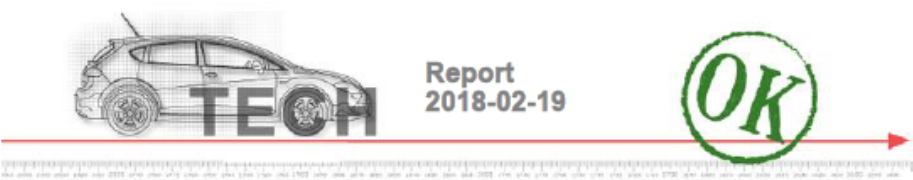
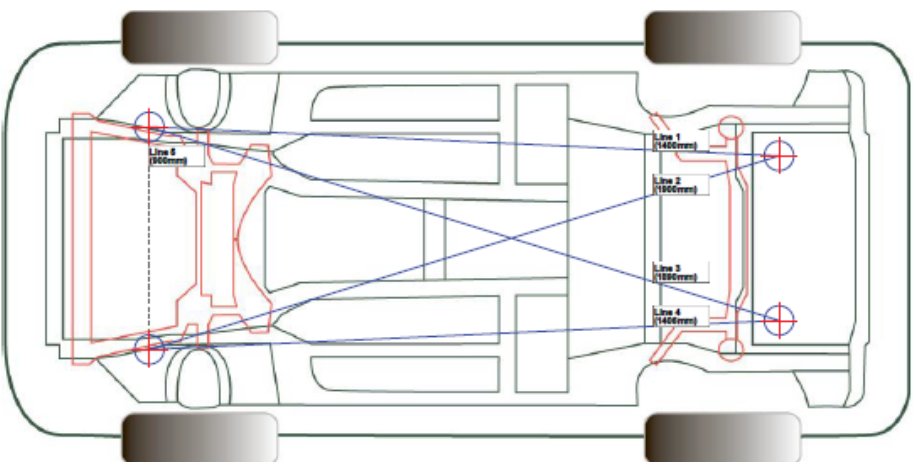
Example of a report on a non-symmetric car

Measured values	Spec. values	
Line 1	1400	1400	✓
Line 2	1900	1900	✓
Line 3	1890	1890	✓
Line 4	1406	1406	✓
Line 5	900	900	✓
